DATE: 31st JULY 2019

BUILDING
SURVEY REPORT ON:

WARSOP TOWN HALL, CHURCH STREET,
WARSOP, NG20 0AL.

Prepared by: *Chandlers Commercial Ltd*

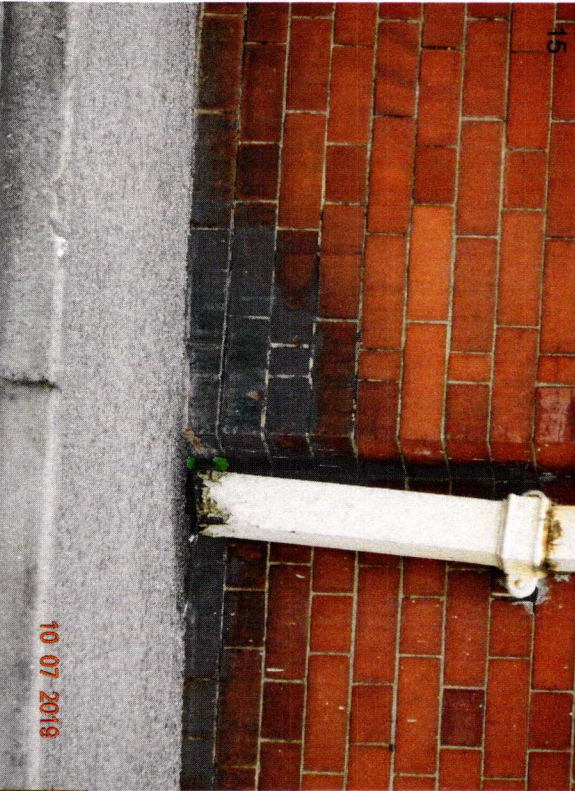
15

4.00 Plumbing & Rain Water Goods	<p>Cast iron gutters with cast iron rain water pipes. Cast iron soil and vent pipe to the left hand side of the two storey part of the building. PVCu waste pipe discharging into a cast iron hopper head serving the surface water disposal to the left hand side of the two storey building. A rain water pipe to the left elevation discharges onto the ground adjacent to the single storey part of the building. PVCu hopper heads and PVCu rain water pipes to the rear flat roof store building. Rain water pipes from the single storey pitched roof to the rear discharge onto the Asphalt flat roof.</p>	<p>Decoration is poor to the rain water goods. Viewed from ground level there are rust stains visible to most joints in the cast iron gutters indicating that the gutters are leaking. However, at the time of the survey it was not raining and this assertion could not be confirmed. There is vegetation growing from the gutters i.e. rear right hand side that should be removed to allow satisfactory surface water disposal and to ensure satisfactory surface water disposal. Rain water pipes are corroded in places to the extent that the pipes have corroded through. There is no birdcage to the top of the soil and vent pipe. Cast iron gutters are unsupported in places. Where surface water discharges onto the ground in proximity of the building it may have an adverse affect on the loadbearing properties of the sub strata that may result in settlement of the building and subsequent cracking. Vegetation growing through the joints in the rain water pipe in proximity of the water street sign. Where rain water pipes discharge onto the Asphalt flat roof this may cause premature failure of the Asphalt through the running water causing wear, it may also cause localised flooding. Surface water visible in the gutters to the rear elevation. It would be prudent to overhaul the rain water good in their entirety to ensure satisfactory surface water disposal and to prevent the ingress of moisture into the building.</p>	15, 22,

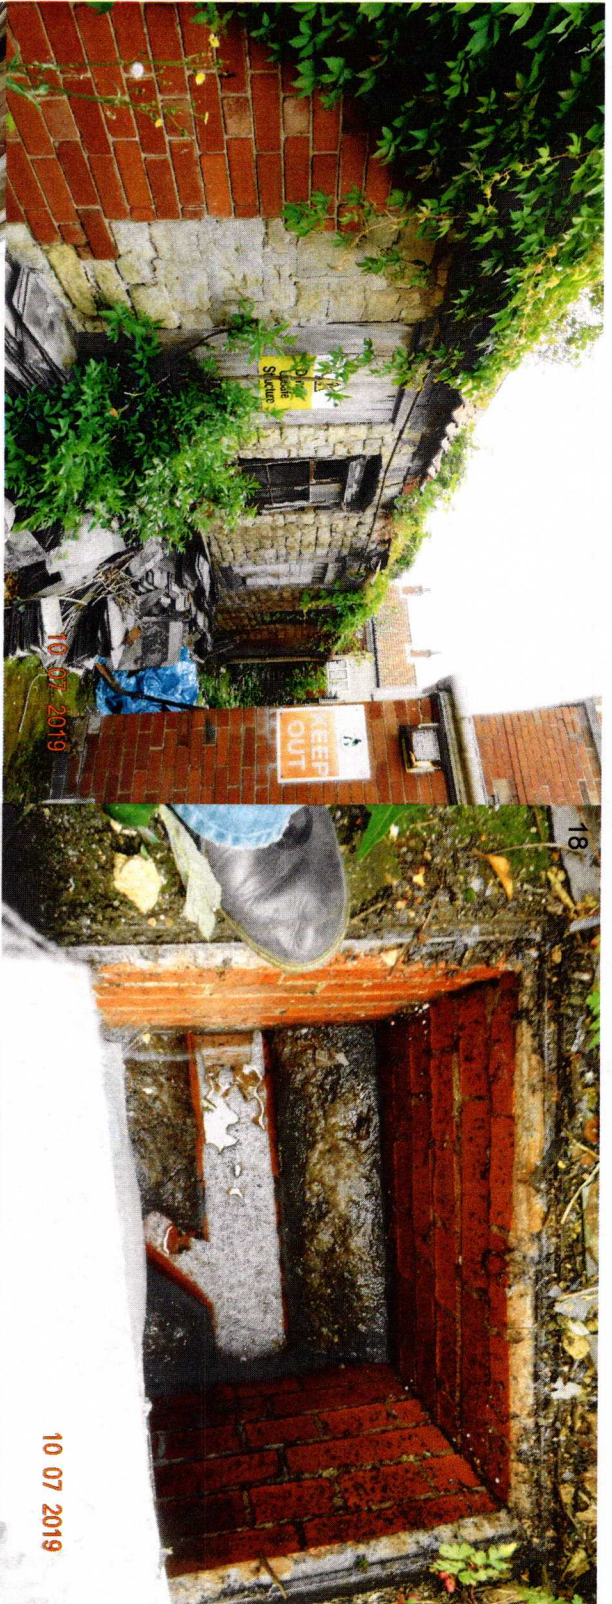
18

There is vegetation growing over the front wall / public conveniences, the building and the outbuildings behind are derelict in poor condition and are at the end of there economic life. From my external assessment only of the derelict outbuildings, the cost of repairing / refurbishing the outbuildings would be extortionate and consideration should be given to their demolition to remove safety hazards. The underside of the canopy is stained at the joints. The steel handrail and balustrade and the steel gate to the passage would benefit from being decorated using a proprietary paint system to prevent further deterioration. Your legal advisor should be asked to confirm the precise demise of the property, ownership of boundaries and responsibility for maintenance of boundary treatments. Decoration poor to the steel fire escape stair that has corroded in places. The stairs should be repaired and decorated using a propriety paint system to prevent further corrosion and deterioration of the stairs. Debris / building materials etc should be removed from the rear yard area to allow means of escape in the event of fire. The galvanised steel inspection chamber cover was raised to reveal blocked drains. It would be prudent to have a CCTV survey undertaken of the underground drainage system to identify hidden defects and allow recommendations to be made for remedial work, this may involve relaying the drains to allow for satisfactory drainage.

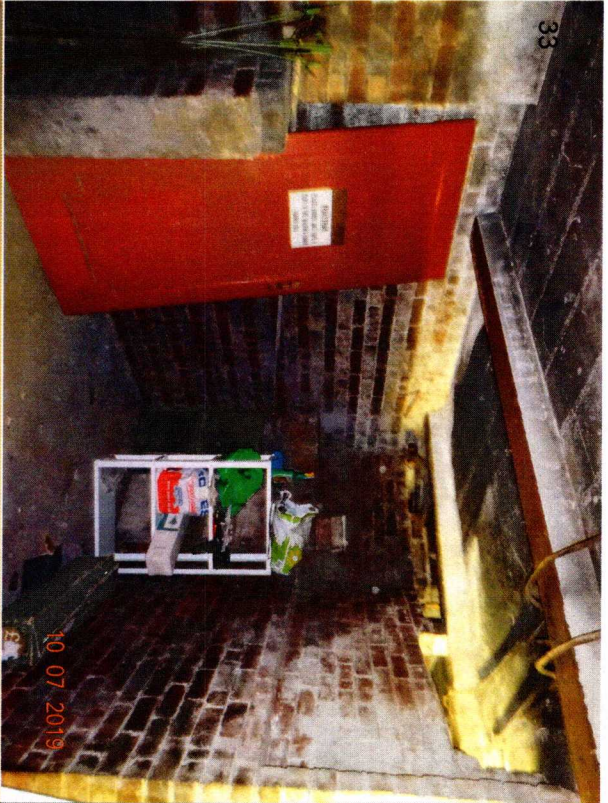
33

Element / Description	Defect / Condition	Image
<p>11.00 Floors / Stairs</p> <p>Mosaic finish to the main entrance lobby. Cast in situ concrete floor to the rear store area. There is a fixed ladder at first floor level affording access to the roof void. Cast in situ suspended concrete floor at first floor level. Hardwood block floor at first floor level in places. Stair lift located on the main stairs affording access to the first floor for disabled persons. Hardwood handrail and painted steel balustrade to the first floor stairwell. Terrazzo floor finish to the first floor in places. Stairs from ground to first floors have quarter space landings with hardwood handrail and painted steel balustrade. Tiled floor to the fire escape route at ground floor level leading to the Library entrance doors. The ground floor is a combination of cast in situ ground supported concrete to the two storey part of the building and suspended concrete supported off steel beams over the cellar area. There are steps down to the cellar located under the single storey part of the building with a handrail to one side. Cast in situ ground supported concrete floor to the cellar.</p>	<p>Cracks through the Mosaic to the entrance door with areas missing. The external store is full of stored materials severely restricting access for inspection purposes, I am unable to comment on the condition of the floor. However the concrete is cracked to exposed areas. Floor finishes in place, carpet raised to reveal a suspended concrete floor, there is a void / hole under the carpet circa 1200mm inside the door of the front first floor office. There should be a disabled persons access audit in place for the building. The stairlift was inoperable at the time of my inspection. Cracked floor on the fire escape route behind the Library entrance.</p>	<p>10, 27, 32, 33,</p>
